Smartphone-Based Close-Range Photogrammetry for Monitoring Heritage Deformation under Extreme Subsidence: A Case Study of the Old Basilica of Guadalupe, Mexico City

Francisco Javier Ramos Organillo,* Nelly Lucero Ramírez Serrato,** José Iván Morales Arredondo,***
Fabiola Doracely Yépez Rincón,‡ Selene Olea Olea¶ y Sergio Armando García Cruzado§

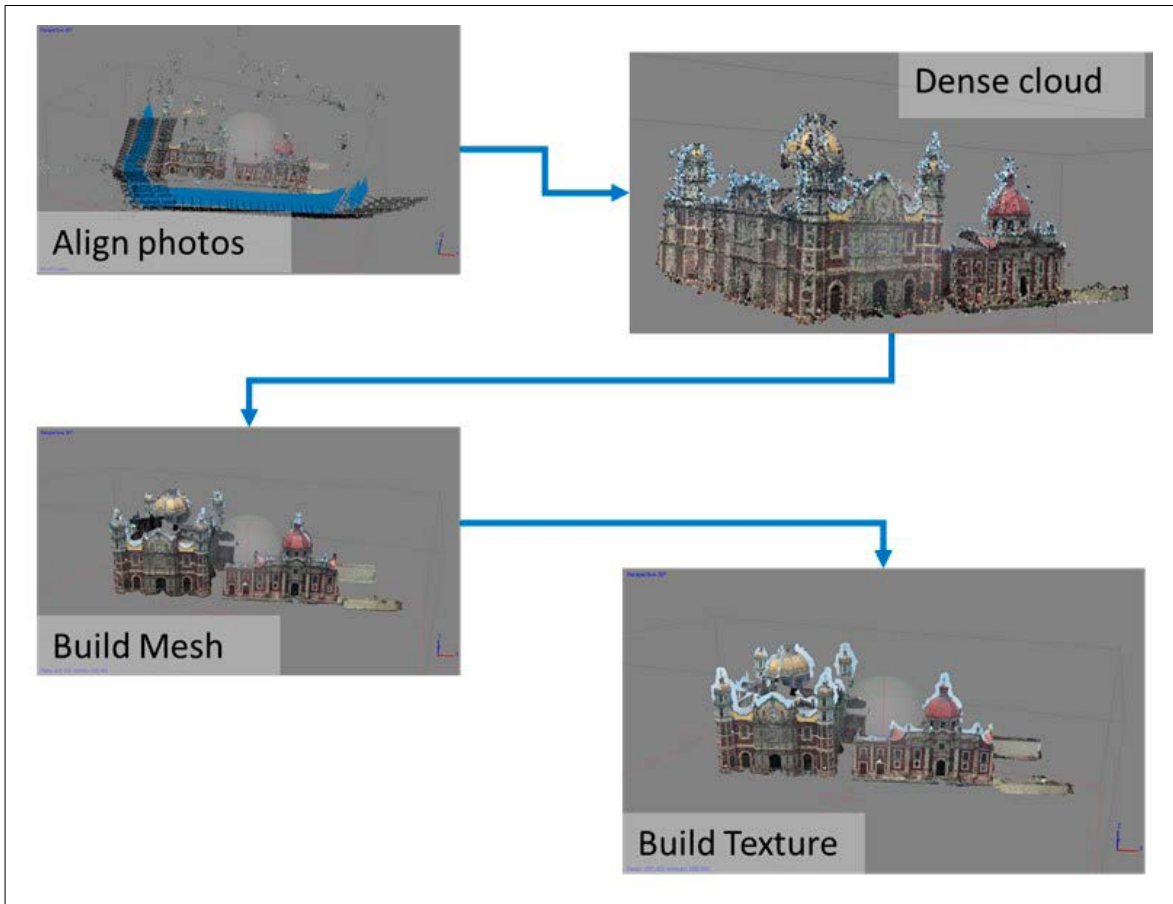
Figure 5. Diagram of the methodology carried out for the construction of 3D models in the Agisoft Photoscan software.

The image set was processed in Agisoft PhotoScan Professional v1.4.5 following a standard Structure-from-Motion/ Multi-View Stereo workflow (Figure 4).

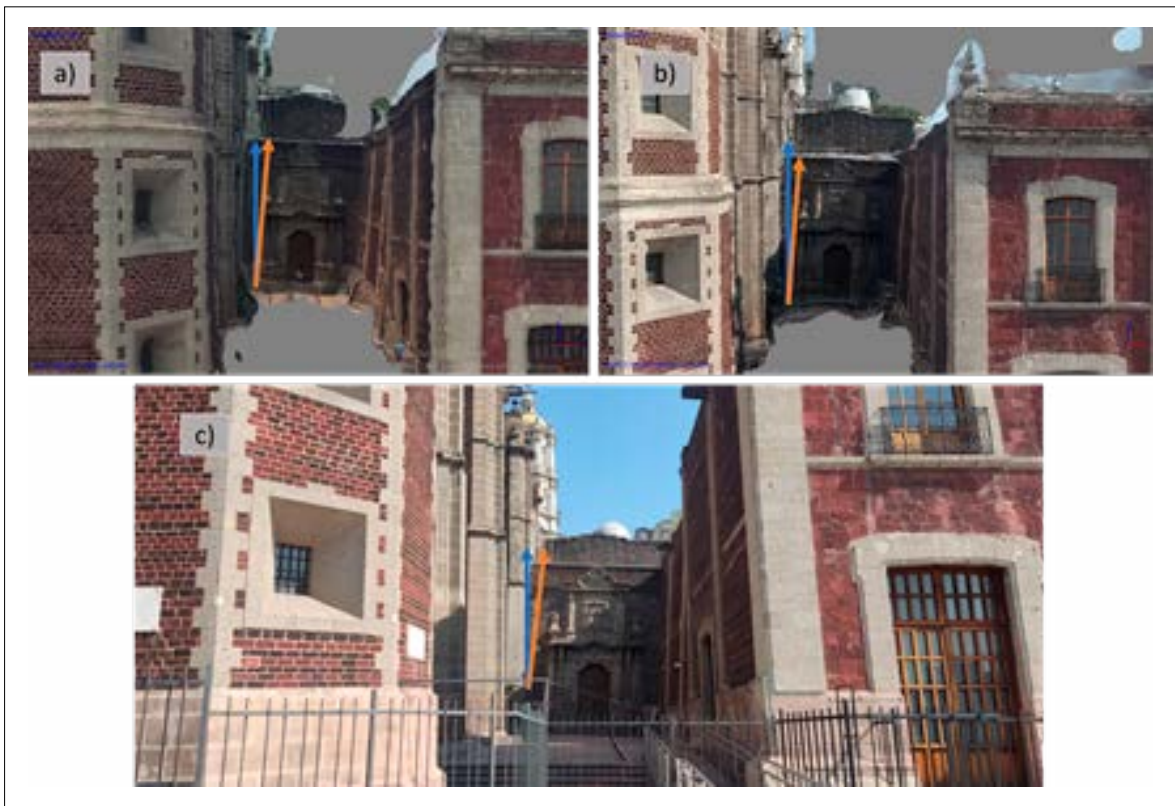
Figure 7. Representation of the property tilt (red line) relative to a vertical reference (blue line). Best 3D models: PL1 (a) and PL2 (b); bottom: actual view of the property (c).

At first inspection, the OBG shows a noticeable southeastward tilt, aligned with the main entrance axis. Evidence of restoration and mitigation measures is visible; however, structural damage continues to progress due to ongoing subsidence. The PL1 survey identified cracks and deformations already reported after the 2017 earthquake.

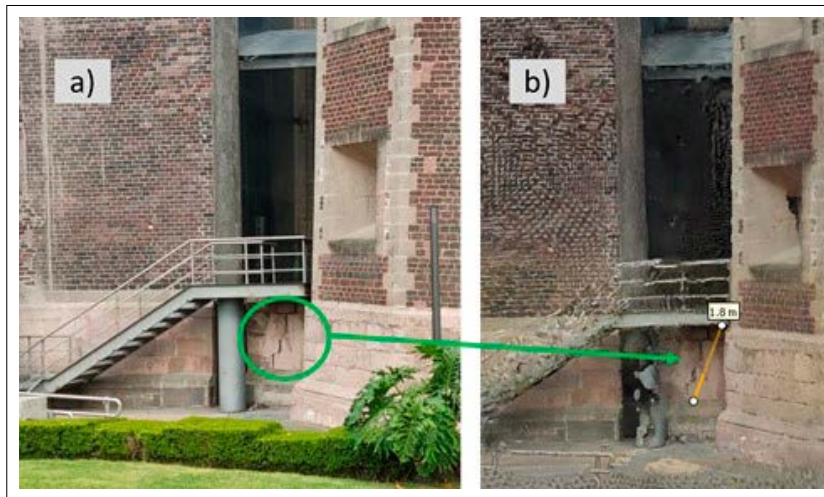
Figure 13. Fracture between the Old Basilica of Guadalupe and the adjacent museum at the rear of the property. a) Field photograph showing the fracture; b) Image extracted from the 3D model.

At the rear of the OBG, a corridor separates the temple from the adjacent Museo de la Virgen. Between these two buildings lies a fissure approximately 1.8 m long (Figure 12). This fracture

spatially aligns with the regional fault line reported by Carreón Freyre (2014) and CENAPRED (2017), marking the boundary between the subsiding OBG structure and the apparently stable museum.
