Analysis of the short term geo-environmental evolution of an endorreic basin using satellite images: the case of Tecocomulco Lagoon, Mexico

Abstract. The Great Basin of the Valley of Mexico was composed of several lagoons that have disappeared due to their geologic evolution and anthropogenic activities. The Tecocomulco lagoon, Hidalgo, is a relict of that basin and has undergone extreme changes in its size and water composition during geologic periods; however, climatic changes, the deforestation of the sub-basin and the agricultural activities have modified its morphology, area and depth, leading to a great accumulation of sediments that fill up the lagoon. The estimate of changes in the lagoon's surface through five decades (1975, 1985, 1990, 2001, 2002) was the objective of the present work using satellite images, jointly with an environmental interpretative analysis. The factors that have modified the Tecocomulco lagoon are: climate, the contribution of a high load of sediments to the sub-basin, agricultural activities and their interaction, to such a degree that its disappearance is very likely, following the same trend as other lagoons of the Great Basin of Mexico.

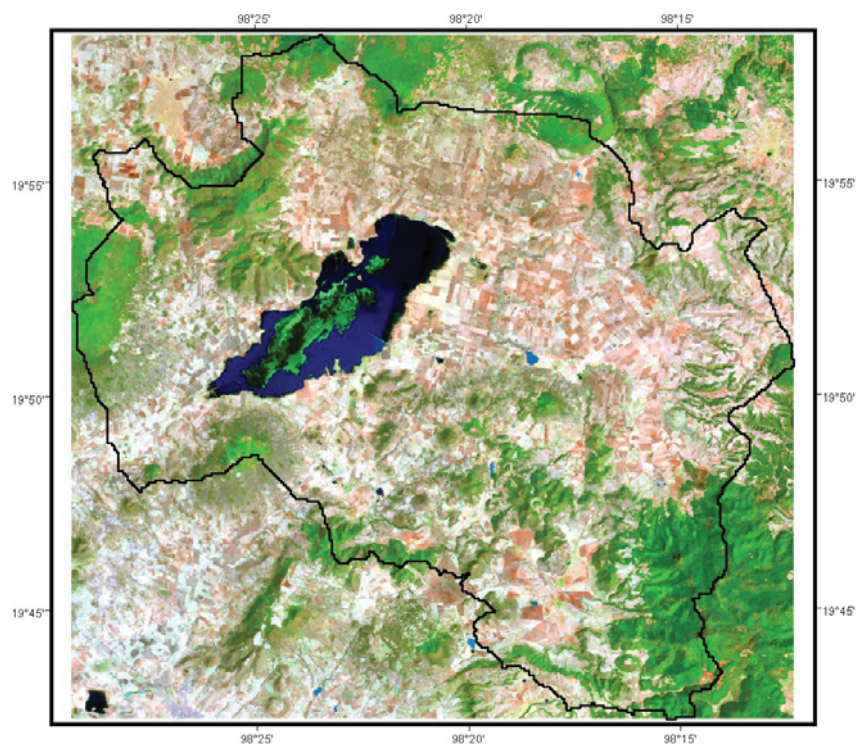
Figure 2. Landsat ETM+ image of Tecocomulco Lagoon and its sub-basin (March, 2002).

Tecocomulco Lagoon is located on the north eastern region of the Great Basin of the Valley of Mexico and represents 5.59% of its total area, as part of a sub-basin measuring 564 km² (Comisión Nacional del Agua, CNA, for its initials in Spanish, 2002; Figure 1, 2), located between 19° 53' N and 98° 21' W (central parallel and meridian), within a basin found at 19° 03' - 21° 11' N and 98° 11' - 99° 30' W, in the central-eastern part of the Trans Mexican Volcanic Belt (Alatríste-Vilchis *et al.*, unpublished). This basin has a tectonic volcanic origin, bordered by several faults that run in a NNE – SSW direction (García Palomo and Macías, unpublished). The bathymetry of the lagoon is flat, with high plasticity clays and dispersed hard clays, with surrounding

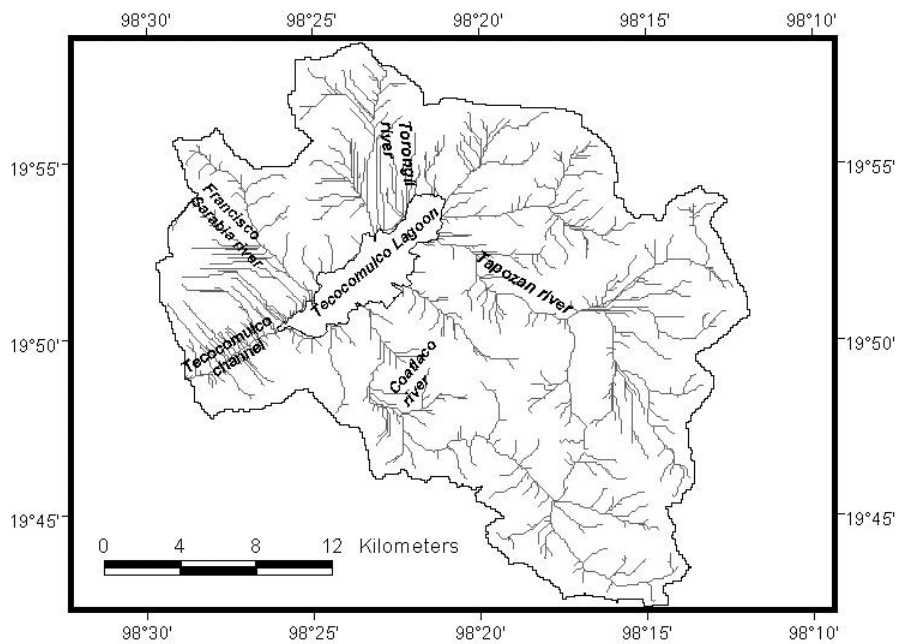
Figure 3. Lagoon of Tecocomulco with its drainage network calculated from digital elevation model.

The Tecocomulco sub-basin is endorreic, with a dendritic drains pattern, and four main fluvial contributions (rivers: Cuatlahco, Sarabia, Toronjil and Tepozan; Figure 3) which do not carry much water due to a low precipitation rate, high evaporation and soil permeability. There are several natural springs in the basin, located mainly in at the south-eastern part (Ruiz-González, 2000). Most of the runoffs are intermittent, with heavy

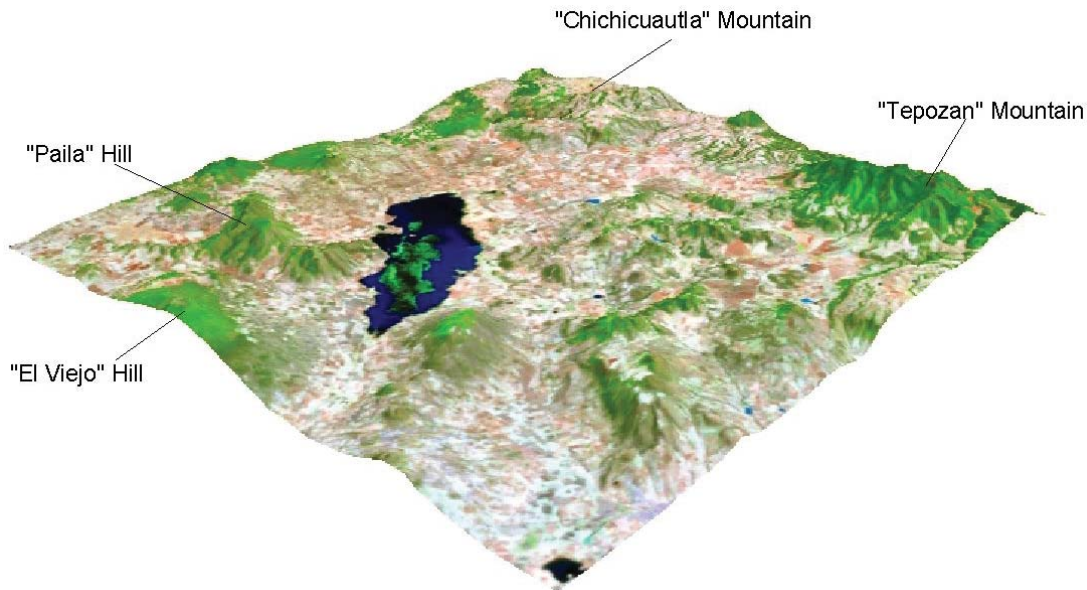
Figure 4. Landsat ETM +image with digital model overlaid.

The lagoon has an elongated and irregular shape, and a variable surface; Ruiz-González (2002) calculates a surface of approximately 27 km². Sediments have a volcanic, fluvial and windswept origin, a mixture that depends on the main activity (volcanic or weather related). The basin is surrounded by volcanoes, calderas, cineritic conus and the Tepozan and Chichicauautla Mountains (Figure 4).

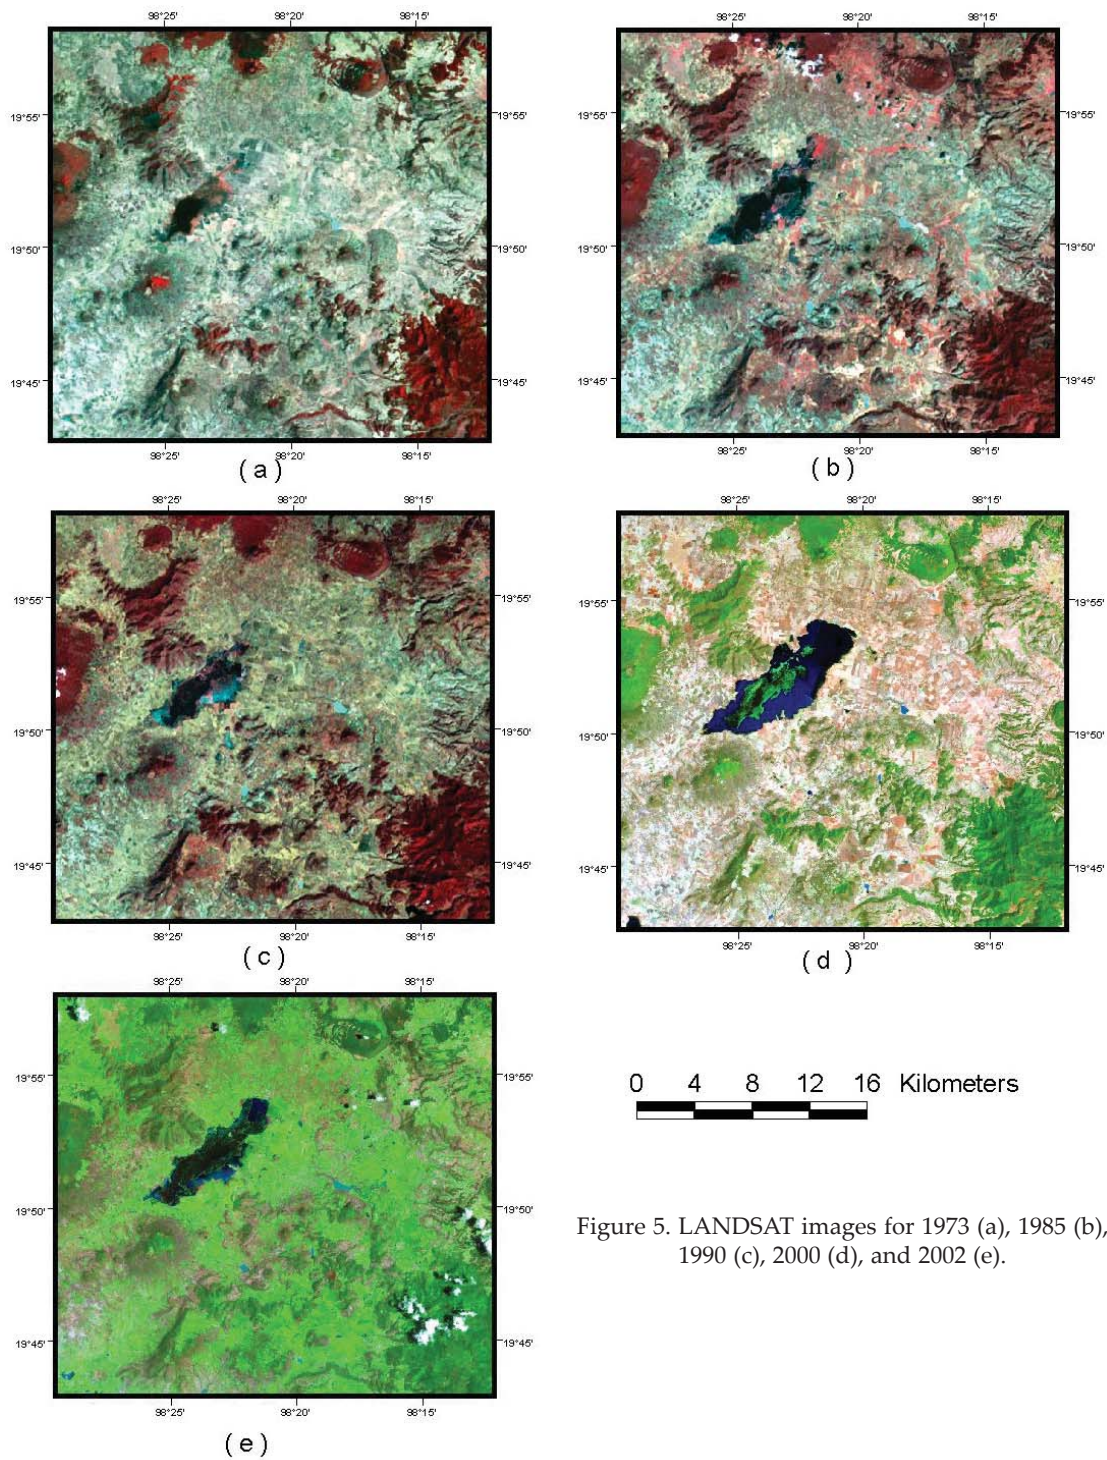
Figure 5. LANDSAT images for 1973 (a), 1985 (b), 1990 (c), 2000 (d), and 2002 (e).

- a) Landsat Image MSS, November 23, 1973
- b) Landsat Image MSS, October 30, 1985
- c) Landsat Image MSS, November 21, 1990
- d) Landsat Image ETM+, March 21, 2000
- e) Landsat Image ETM+ August 2002
- f) Landsat Image ETM+ 2002 classified
- g) Map of change land use and vegetation, INEGI 1976, 2000-2001 for the sub-basin.

The outline of the lagoon was drawn on screen with the 73, 85, 90 and 2001 images using Arcview GIS 3.2, then the surface of the water body in different years was calculated (Figure 5).

(27 km²), with the lagoon presenting a very irregular configuration. Based on the morphology presented by this author, the 1973 image (Figure 5) indicates that the area which lost the highest volume of water and was most silted was the NW area, which corresponds to the foot of the mountain, between the "La Paila" and "Del Viejo" hills (both of which belong to the Chicicuatla Mountain), the most eroded section and the source of sediments (> 12 ton/km²/year, Huízar-Álvarez *et al.* unpublished), and the place where the lagoon receives more direct tributaries. It must be said that in 1972-73 there was a strong draught associated with the "El Niño" phenomenon, (maximum) according to the NOAA scales (2004) that affected the entire country; thus, it is possible to consider that this climatic phenomenon had to do with the significant decrease in the lagoon's water. In support of this, Ruiz-González (2000) indicates that during 1996 and 1997 there was almost no rain and that in 1998 the lagoon dried completely, El Niño occurred during these years and was considered one of the most severe events in the 20th century.

- 1973 El Niño (strong), high evaporation rate with a decrease in precipitation and runoff (Figure 5a)
- 1982-83 El Niño (strong), high evaporation with a decrease in precipitation and runoff.

- 1984-85 La Niña (strong), increase in precipitation and runoff (Figure 5b).
- 1986-87 El Niño (from moderate to strong), evaporation > runoff.
- 1988-89 La Niña (strong), increase in runoff.
- 1990-93 El Niño (from moderate to strong), high evaporation rates with a decrease in precipitation and runoff (Figure 5c).
- 1995-96 La Niña (weak), increase in runoff (Figure 5d).
- 1997-98 El Niño (strong), high evaporation rates with a decrease in precipitation and runoff (Figure 5e).
- 1999-2001 La Niña (from moderate to strong), increase in runoff.

The images for 1973, 1985 and 1990 (Figure 5) show that the desiccated areas which had a high degree of silting are associated with the two most important permanent rivers: the Tepozan to the east, with its water held by the Tezoyo Dam, and the Cuatlahco river to the southwest, which feeds the Benito Juárez dam. The Sarabia river, which passes through the El Viejo hill, is seasonal and feeds the lagoon only during the rainy season, as it infiltrates during the dry periods. It should be mentioned that there is a natural underground exit to the southwest, through faults and fractures.

In spite of Ruiz-González (2000,) who indicates that the Cuatlaco river is the only one feeding the lagoon throughout the year, the images for 1973, 1985 and 1990 show that the place where the river discharges is also where more surface has been lost; this can be the result of water management through the dam for agricultural purposes. In 1973, the advance of agriculture in terms of land was not evident as a cause for the reduction in the lagoon's surface for irrigation purposes or for gaining land from the lagoon's own body through the construction of small dams for future agricultural areas. Nevertheless, this study –based on INEGI's cartographies of 1976, and from the Instituto de Geografía de 2000 (Figure 7)– calculates an agricultural increase of 9.3%, as is shown in Figure 8 and, precisely the region where Ruiz-González (2000) indicates, is found the highest concentration of canals built to improve the drainage from agricultural areas and to stop the water from becoming stagnant. Agricultural workers have also built small dams to hold water for irrigation, and which, once dried, will provide extra land from the lagoon, as has happened in the northeastern area. This can be seen in the 1990 and 2000 images (Figures 5).

The tendency of the drain to increase, registered by Ruiz-González (2000) in a 14 year time lapse (Figure 6), from 1980 to 1994, can be corroborated with the tendency of the flooded area to increase from 1973 to 2002 (Figure 5), as can also be seen in figure 9. In 2000, considered as a La Niña year, the surface of the lagoon was calculated on the image, as having 35 km², against the 27 km², quoted by the author. It should be said, nevertheless, that the northeastern side had a low water table, referred to as a muddy area (Figure 10) and which borders with the high density (irrigated) agricultural area as well as with the area located to northwest, in the foot of the mountain at the Chichicautla mountain, which is smaller and has seasonal agriculture. This last area coincides with the highest input of sediments from erosion (between 3.1

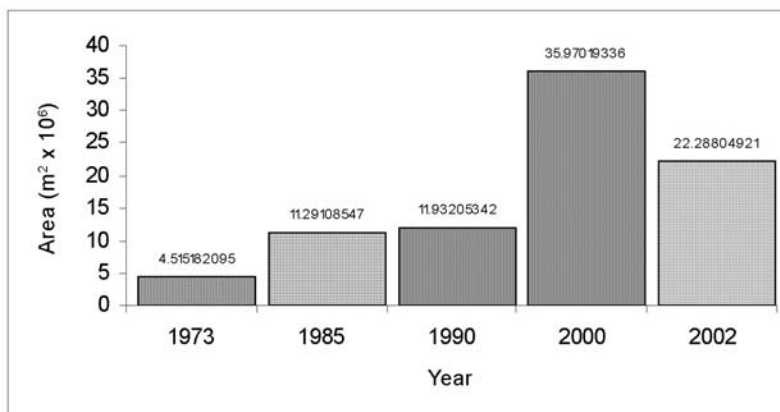
Figure 6. Coverage fluctuations calculated from LANDSAT images. Coverage fluctuations calculated from LANDSAT images.

According to Ruiz-González (2000), from 1981 to 1994 there was a tendency of the drain to increase, although oscillations due to draughts and severe rainfall can be associated with phenomenon El Niño that have a certain periodicity, as can be seen in Figure 6.

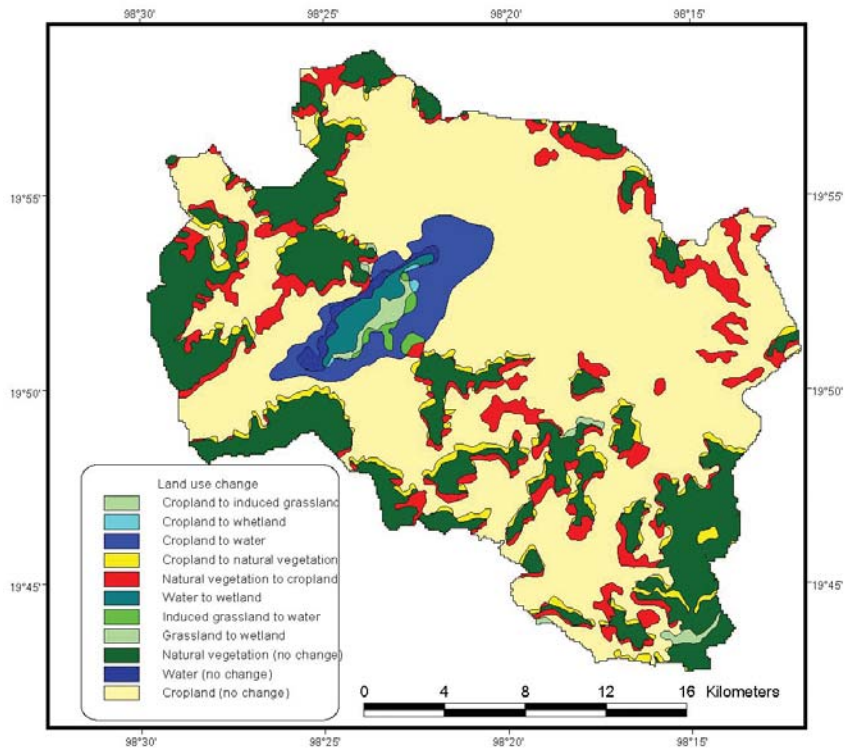
Figure 7. Land use changes in Tecocomulco sub basin from 1976-2000.

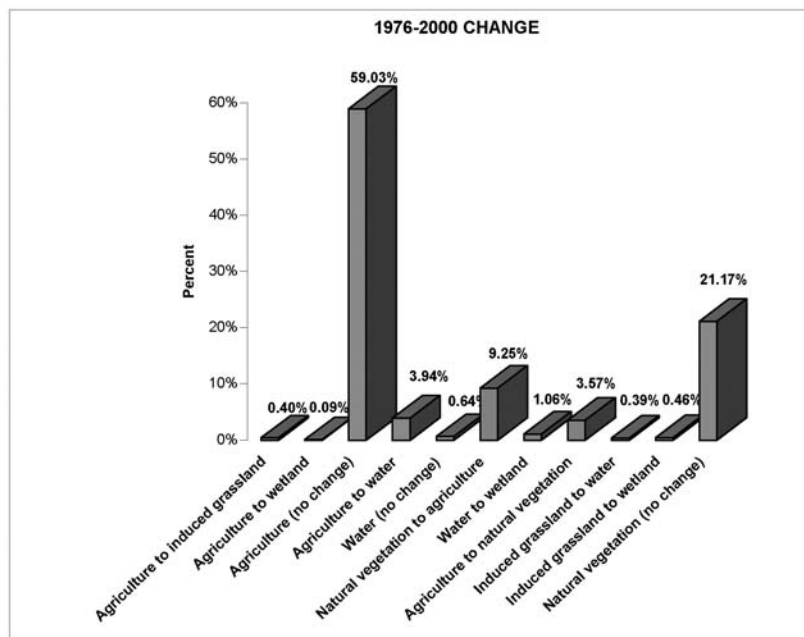
Figure 8. Land use change from 1976 to 2000.

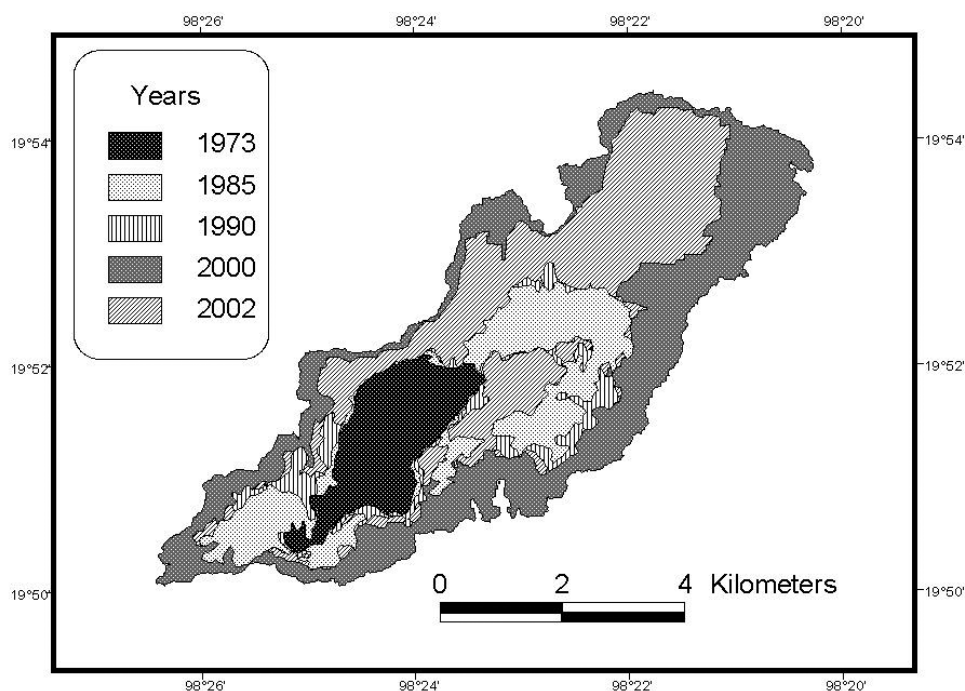
Figure 9. Coverage change of the Tecocomulco Lagoon between 1973-2002.

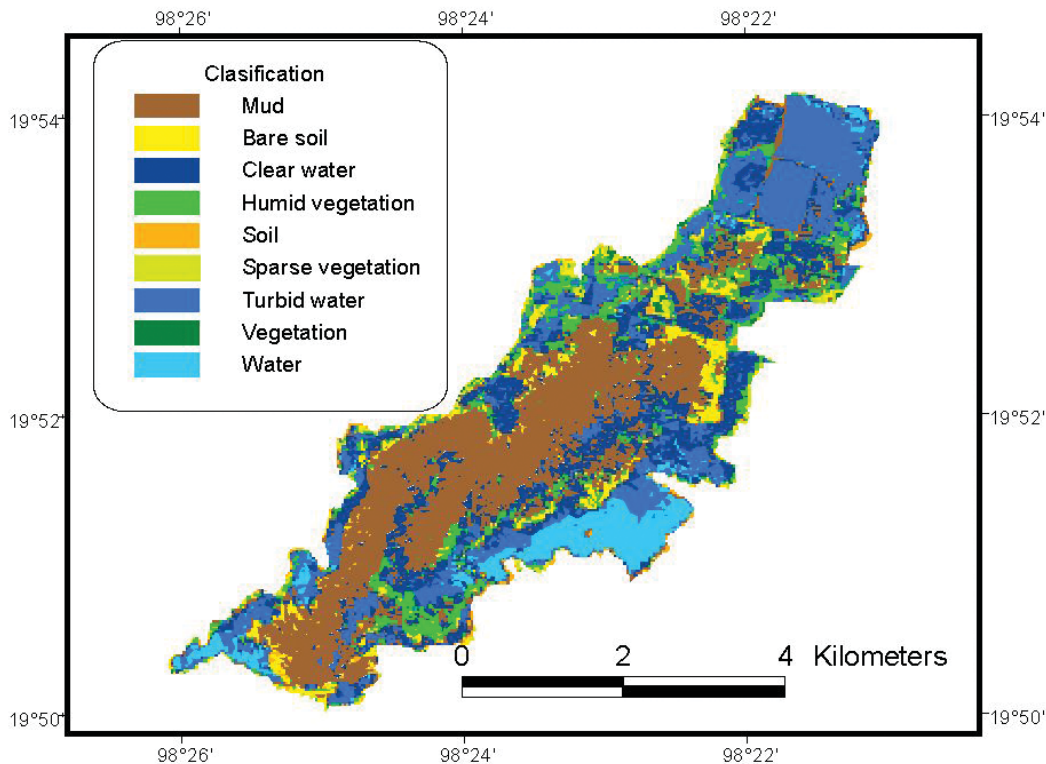
Figure 10. Classified Landsat ETM+ of 2000.

to 8.1-12.0 tons/km², according to Huízar-Álvarez *et al.*, 2003), seen desiccated in the 1973, 1985 and 1990 images, with high possibilities of flooding during periods of intense rainfall, and with shallow depths (muddy areas) as seen in the 2001 image (Figure 10). It is important to state that the heterogeneity in flooded and desiccated areas can be the result, among other things, of the sediments moving to form deltas at a sedimentation rate of 5.7 cm/year, as indicated by Ruiz-González (2000).
